Effects of Via Slots, Split Planes, Gaps and Return Paths on Clock Signals

By: Rick McMurray – VP, Operations

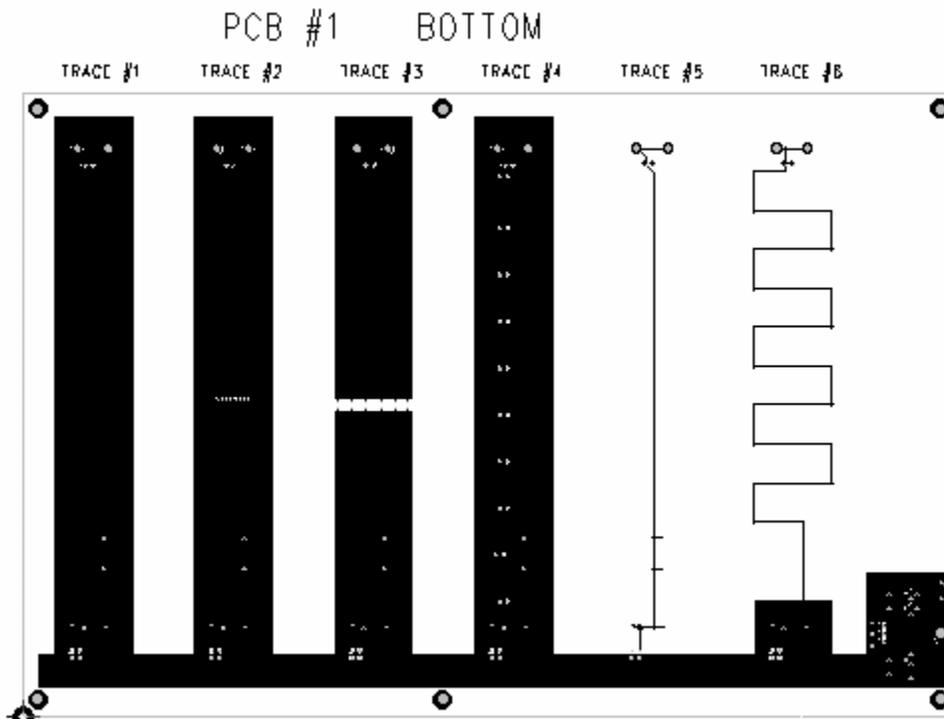
Figure No. 1

The PCB designed for this experiment consists of six individual sections, labeled TRACE No. 1 – TRACE No. 6 (Figure No. 1

below shows the bottom side of the PCB). Each section consists of a 50MHz oscillator driving a trace. There are also pads for three passive components, but they are not used except for a 0 ohm resistor in the location for a series resistor in the clock line (these pads were included for future experimentation). In each section, other than the first, I have illustrated an example of a situation to avoid if possible. The PCB constructed was a two layer 0.062” thick board. The signal traces and power distribution are on the top layer, and the bottom layer consists of individual copper fills that act as ground planes (TRACES 1 – 4). On Traces 5 and 6, the return path is a trace on the bottom side.

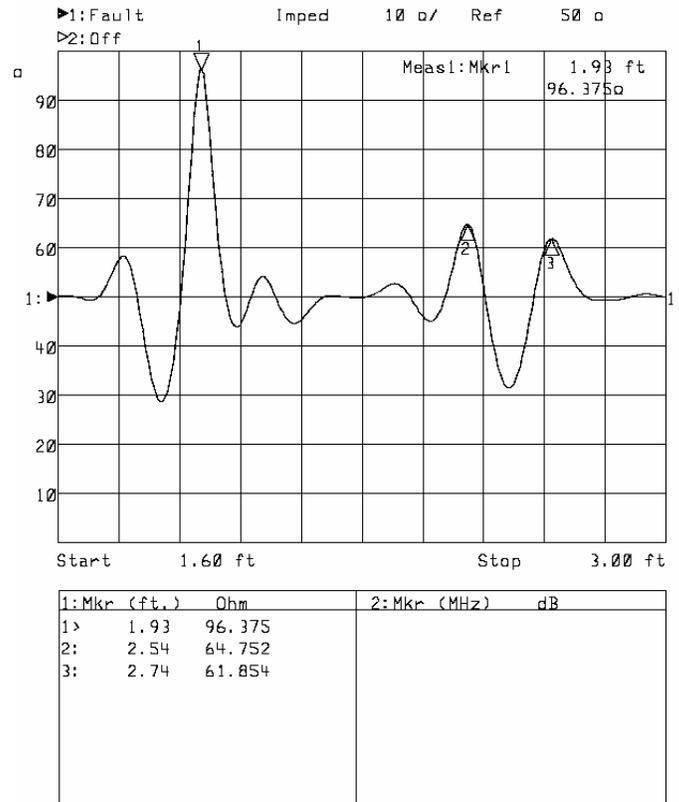
Figure No. 2 (TRACE No. 1)

Figure No. 2 is a plot from a network analyzer showing trace impedance versus distance. Marker No. 1 points out a large impedance mis-match due to the output BNC connector. Marker No. 2 shows a slight mis-match due to the series 0 ohm resistor, and marker No. 3 shows a slight mis-match due to the output of the 50MHz oscillator. The point to note from figure No. 2 is that the trace maintains relatively constant impedance from the 0 ohm

resistor to the output connector.

Figure No. 3 shows the impedance versus distance plot for Trace No. 3. The plot illustrates the same impedance mis-matches as figure No. 2, but with one significant addition. Note the mis-match shown by marker No. 1 in figure No.3 – this is the impedance mis-match caused by the clock trace crossing the gap in the ground plane. (The plot for Trace No. 2 had a similar mis-match due to the slot, but it was not as drastic.)
